TREATMENT AND REPAIR OF PARTIALLY DAMAGED RETAINING WALLS IN HILLS

V.P. GUPTA* & N.K. LOHANI.**

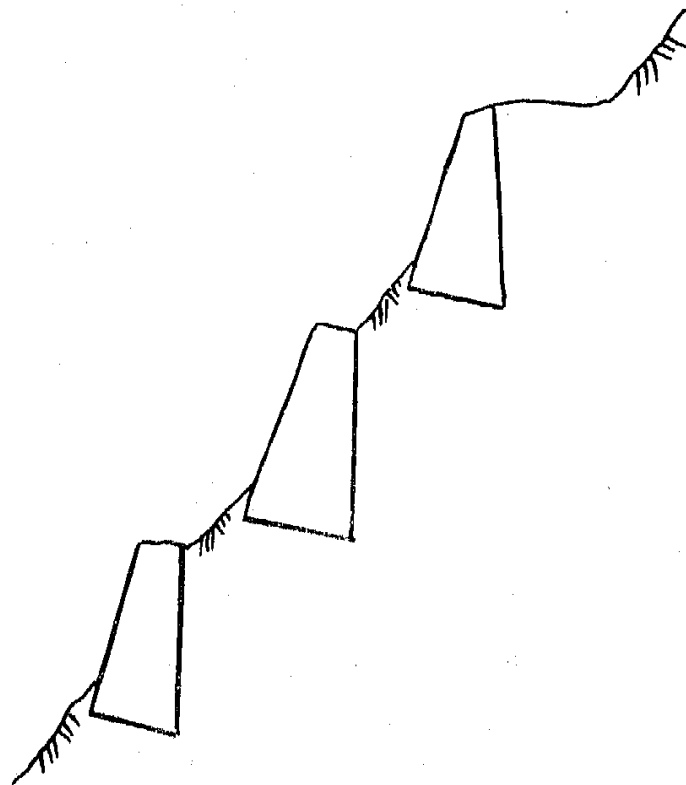
Sometimes, successive retaining walls are constructed one over the other as shown in Fig. 2. This is a wrong practice as toe of upper wall causes heavy surcharge pressure on back of lower wall to which they may not stand. Such walls have been seen damaged most often if backing is of soil or soil mixed with stone boulders. Such successive walls may remain stable only when backing has a high percentage of stable rock, causing only a nominal back pressure.

Fig. 2 - Successive retaining walls

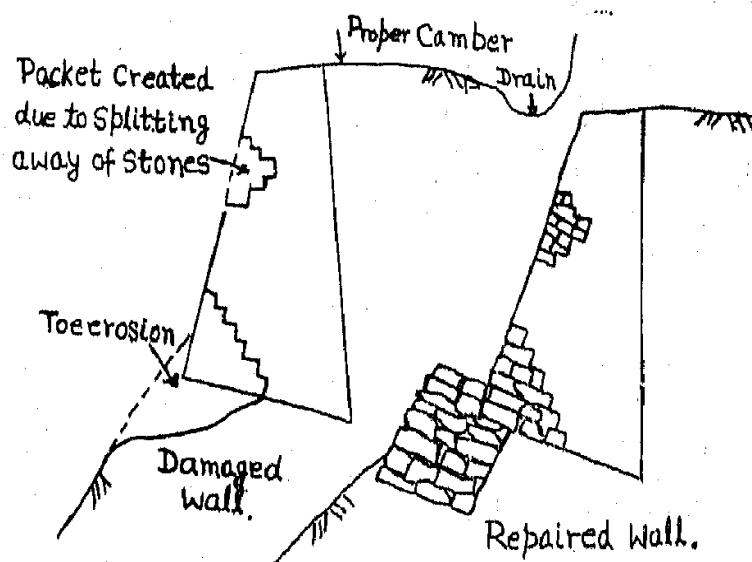
Sometimes empty pockets are developed in the wall due to splitting away of few of the masonry stones. Such pockets enlarge in due course of time and ultimately result in the collapse of the retaining wall, fully or partially, if they are not treated in early stage as soon as it is noticed. Whole of the wall does not collapse till the arching action among the stones is able to bear the forces. In such case, stones should be placed in pockets tightly, so that they become well interlocked with parent masonry stones, Fig. 4. A proper toe

Fig.—4 Repair of retaining wall affected by erosion or loss of stones

wall should be constructed, if the failure occurs near the toe due to erosion of the base soil or rock, or due to base failure. Such erosion generally occurs during heavy rains. This type of remedy has been tried by the Authors for many retaining walls and found successful.

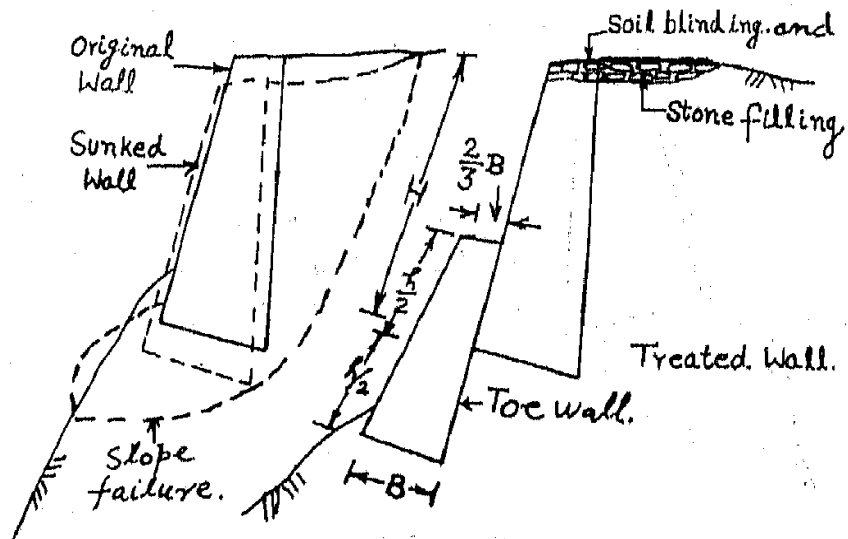
These failures occur only in rainy season, because soil strength parameters get degraded on wetting. If only partial damage occurs due to sinking, then it means that soil or rock lying below the base has gone to compression and consolidation. For such cases it will be better to make additional wall like toe wall in front of original wall as per details given in Table 1 and Fig. 5. The sunken depth may be filled up by hand-packed stones to get required original road surface.

Fig.—5 Repair of wall subject to sinking

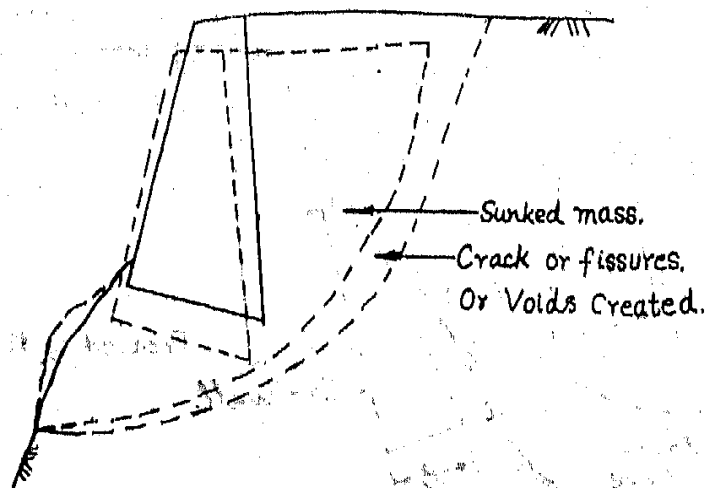
4.2.2. Slope failure resembles spheroidal or parabolic shape. A wide crack or gap may develop on the surface as failure progresses. It becomes only a partial failure, if base soil or rock is able to bear weight of departed masses at any lower level as shown in Fig. 6. Such cases may be treated by construction of a toe wall or by grouting as explained in para 4.2.1. It would be better if grouting is done along the fissures or the gaps developed. This would result in a honey-combed solid mass.

Fig. 6—Slope failure

Whole of the grouting should not be done in one day or in one operation, as the fluid grout may exert a high back pressure and lubricate the mass which may cause complete collapse of the wall. Only 5 per cent length should be grouted on each day in first 5 days. Then a gap of 15 days should be given for curing and strengthening of grouted mass. Whole of the remaining grouting may be completed on 16th day and onwards. After completing 10 per cent length, the mixture may be changed to 1 part cement, 1 part medium sand and 1 to 1.5 part water. If the fissure is wider than 10 cm, after completing the first 10 per cent length, grouting mixture may be changed to 1 part cement, 1 part sand, 2 parts of 10 to 20 mm size grit or river shingle, and 2 parts water. Grouting should never be done when the ground is saturated. Dry ground would allow quick soaking or

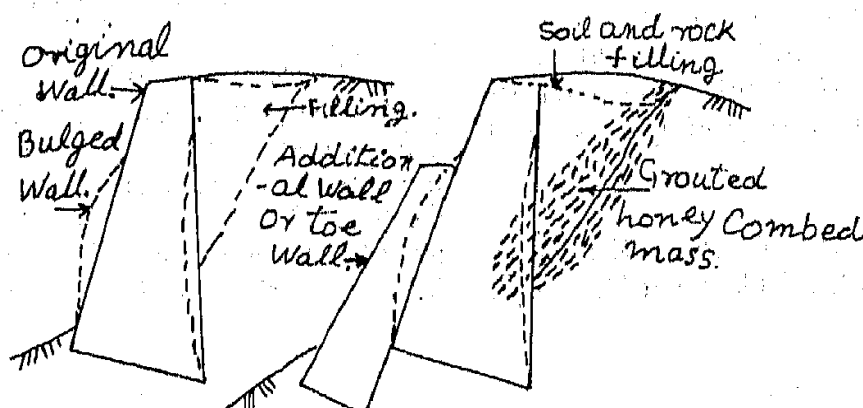
4.2.4. Bulged retaining walls : This type of failure resembles a column failure in building or shearing as shown in Fig. 7. This may be treated by construction of a suitable toe wall, or by grouting, or both. Sometimes enough space for toe wall may not be available. In such case, surface grouting may only be a reliable solution.

Fig. 7—Bulged retaining wall

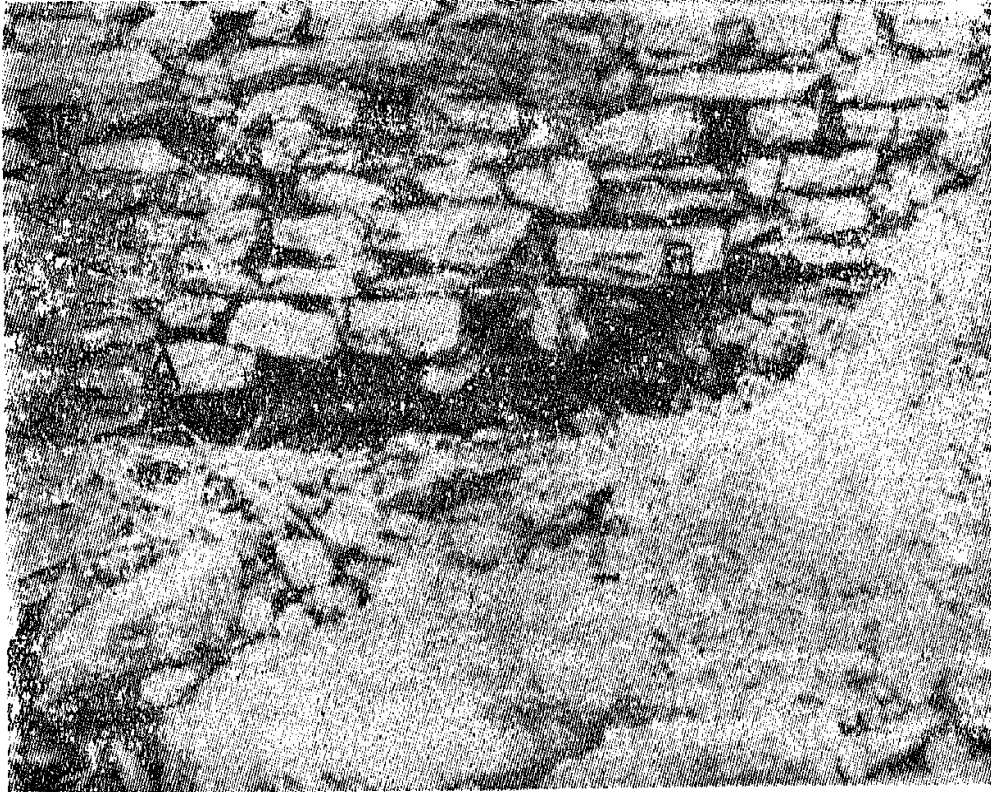
5.1 Toe of a 7.5 m high mortar masonry retaining wall was seen eroded forming large pockets as shown in photo 1 soon after the first rainy season of their construction. This was due to fall of rain water from top and heaving of soil lying below toe on Pauri-Kholachori road, km. 2. The pocket was filled up tightly and a toe wall was constructed in dry stone masonry by maintenance gang as explained in Fig. 4. It has functioned well for last four years, saving the wall from complete collapse. Similar treatment has been done to dozens of other retaining walls on a number of roads in district Pauri Garhwal (U.P.).

Photo—1. Loss of stones and formation of pockets in retaining wall because of water erosion

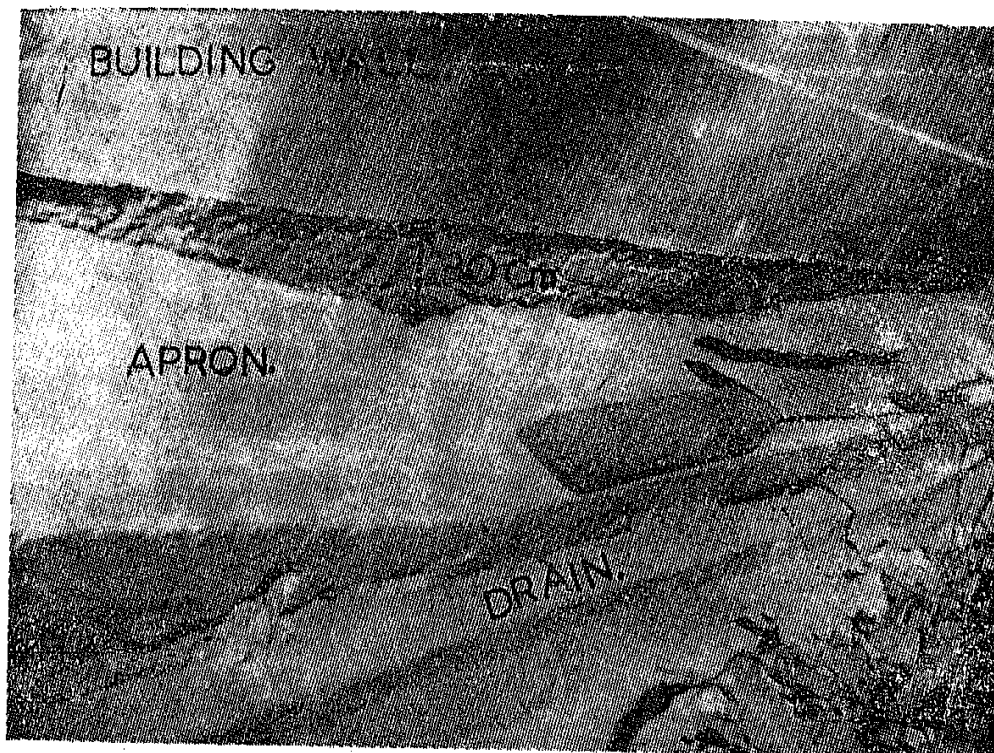
Photo -3. Close view of a hill cut slope failure

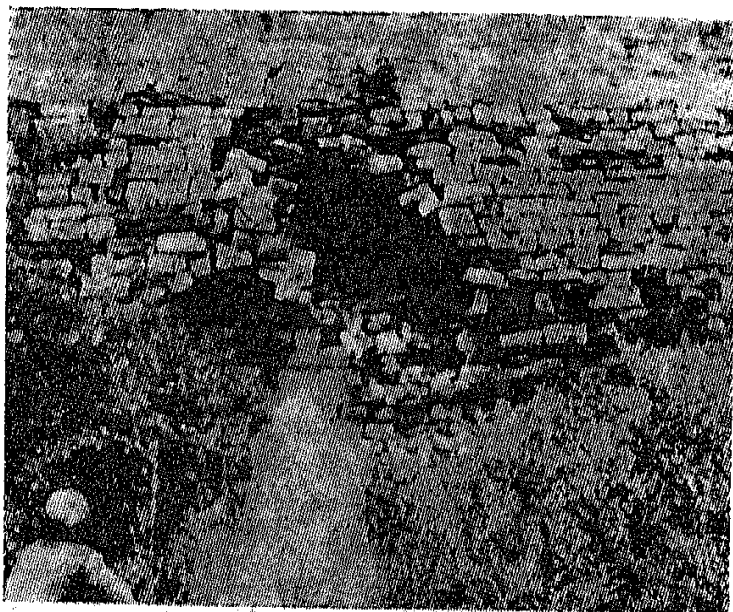
5.5. Photo 4 shows a partially failed retaining wall due to bulging and loss of stones at km 20 of Almora-Pandhar road. This was repaired by packing the voids tightly with stones and constructing a supporting toe wall, see Photo 5.

Photo 4. A retaining wall subjected to bulging and loss of stones

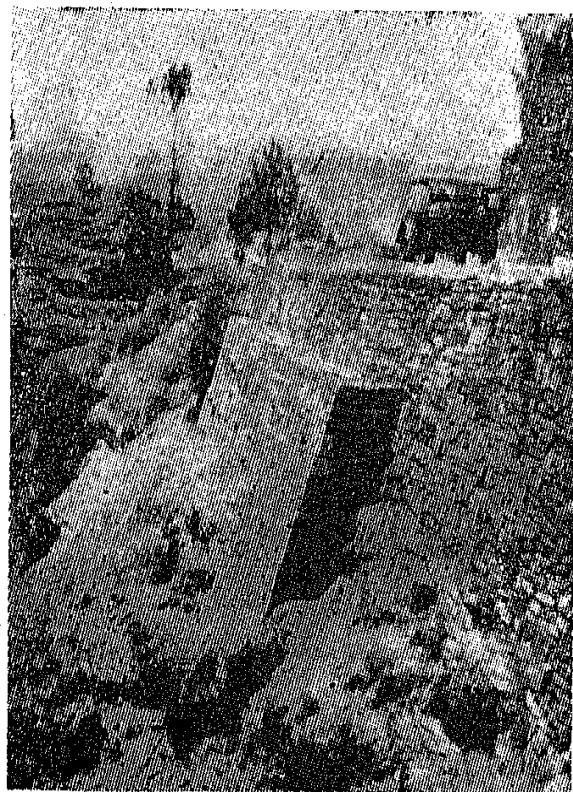
Photo-5. The wall in photo 4 after repairs. The voids were tightly packed with stones and a toe wall built for support
