TREATMENT AND REPAIR OF PARTIALLY DAMAGED RETAINING WALLS IN HILLS

V.P. GUPTA* & N.K. LOHANI.**

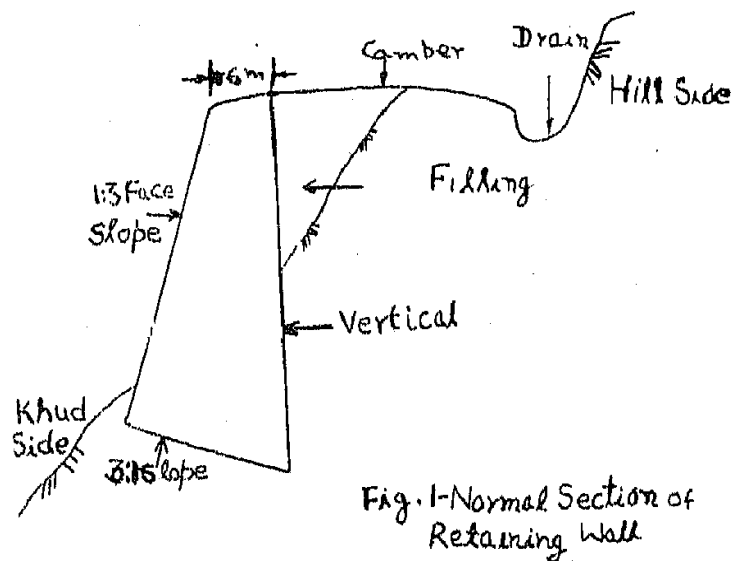
Quite often retaining walls are made of a single standard section in all sorts of soil and rocks irrespective of anticipated back pressure consideration. Normally adopted section consists of top width 0.6 m face slope 1 : 3 (1 horizontal and 3 vertical), and vertical back slope. Base is given 3 : 1 inward downward slope for keying it as shown in Fig. 1.

Fig. 1—Normal section of retaining wall

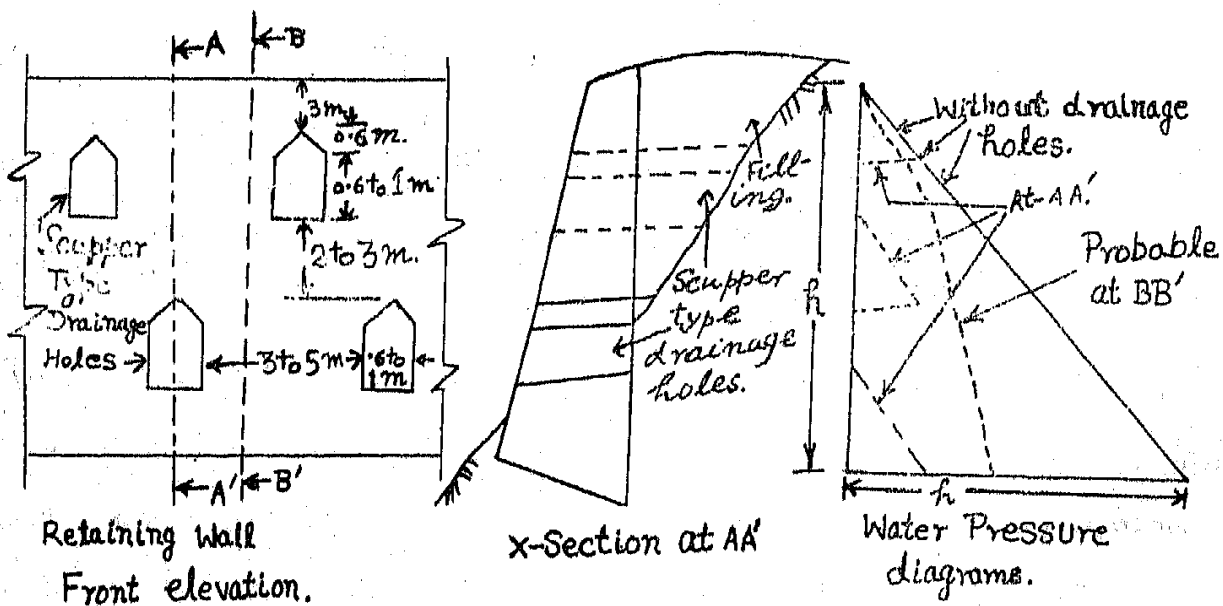
Fig. 3 - Retaining walls with scupper type weep holes

about 0.6 m x 0.6 m to 1 m x 1 m scupper type as shown in Fig. 3. These are easy for inspection and cleaning. Moreover, it will reduce anticipated back pressure by quick drainage of seeping water.

high retaining wall of height about 7 m collapsed many times though constructed in cribbed and banded masonry. In October 1980 it was reconstructed with 1 m opening scupper type drainage holes as explained in Fig. 3. This retaining wall is intact even today. Similar drainage holes of width 0.6 m have been provided in 9 m high dry stone masonry retaining wall in km 22 of Sungerhal-Sikukhal-Jwalpa Devi road in district Pauri Garhwal in April 1981, and 8 m high dry stone masonry retaining wall in km 1 of Chharonj-Chalnichhina road in Almora district. These have been found successful and the walls have not shown any sign of collapse. Similar drainage holes are being provided in several other retaining walls.
